MARYLAND GEOLOGICAL SURVEY Merryman Hall The Johns Hopkins University Baltimore, Maryland 21218 (301) 235-0771

COUNTIES (MD/PA)	WASHINGTON/FRANKLIN
M&D milestone no.	94 (97)
MHT-HSI no.	WA-IV-094
	•

FIELD SHEET: MASON & DIXON LINE, MARYLAND-PENNSYLVANIA BOUNDARY MARKER SURVEY

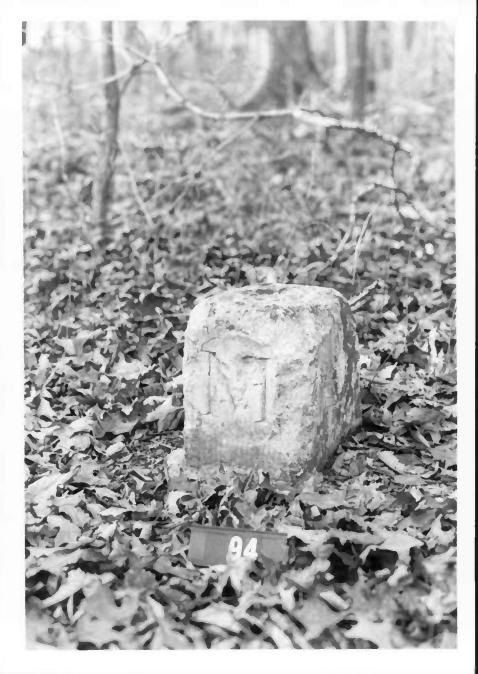
MASEN EUXUN WESTLINE! MILESPONE 94 (49) SE CORNER (M/-)

S face (MD): 10¾" wide x 13½" high; M clear but chipped, circle panel nearly intact; some fluting no margins remain; big chips SE corner & side edge

97. Original monument in solid foundation; chipped on all corners and top, worst being northwest and southeast corners. Lettering badly damaged, especially "M" 1979-81 Inspection notes: order no. 94 (97); photos/negatives/slides no.94 (97) 94 (97). Original M&D milestone of 1767 in place, in good condition, firmly set. Letters distinct, but M chipped; chips all edges and corners, especially

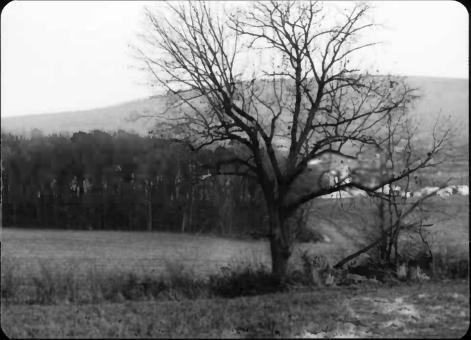
MEN SE TOWARD WOODS (STONE IN CENTER OF WOODS) EWORTHING TON FART BUILDINGS
PHOTO: ALICE MARTIN (1981. 2.7) 11/22/80

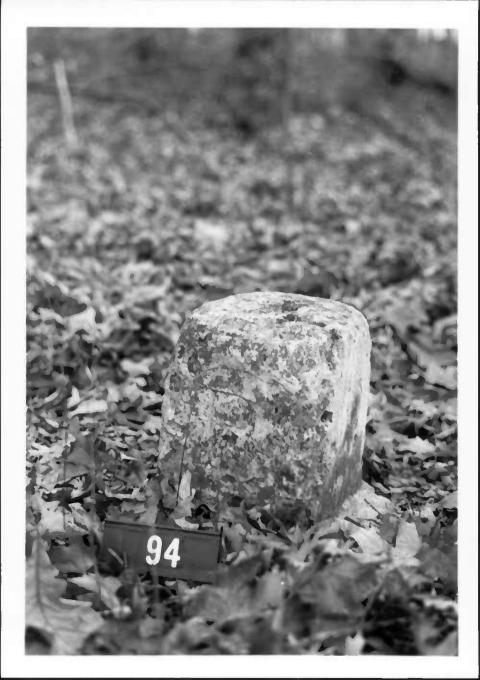
MARNIDIXON WE TILE MILE TILE IN 9-1

W face: 12¼" wide x 13½" high: most fluting no margins remain; bullet hole 12/4" wide x 13" high; most fluting no margins remain; bullet hole
NW edge; chips all edges & corners
planes gone, large shallow depression in center; chips all edges & W face: top:

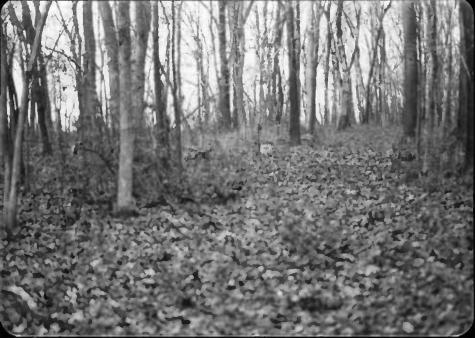
HED DEST LINE; MILESTONE 94 (97)

VIEW OF STONE & SETTING, LOCKING NNW
ALONG WOODS PATH

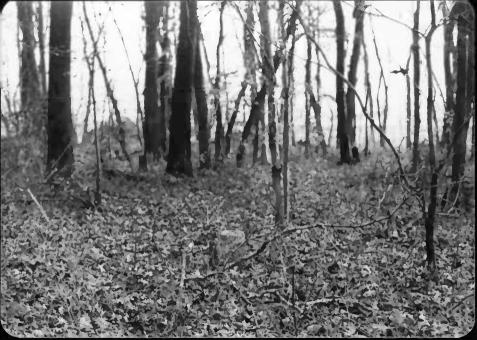
HED WEST LINE; MILEGTONE 94 (97)
VIEW OF STONE 2 SETTING, LOOKING—SE
TOWARD WORTHINGTON FARM
PHOTO: ALICE MARTIN (1981.2.3) 11/22/80
